Oppdragsgiver Client BEWI Norplasta AS Postboks 3009 Lade 7441 TRONDHEIM NO		Utførende enhet/lab. Department/laboratory responsible Kiwa AS Materials Technology P.O.Box 1019 NO - 3601 KONGSBERG	
Rapportnr. Report no. 3000-21-100093			
Tittel Title Testing at BEWI Norplaste AS of BEWI Smart universal protectors			
Dato Date 11.06.2021	Utarbeidet av Prepared by Mona Kirksæther <i>Mona Kirksæther</i>	Godkjent av Approved by Asgeir Haukaas <i>Asgeir Haukaas</i>	Innleveringsdato for prøve Date of receipt of test object 27.05.2021
			Prøvetaking utført av Kiwa Sampling by Kiwa Nei No
Revisjonsnr. Revision no. -	Konfig.kont. Config.contr. Ja Yes	Antall sider No. of pages 21	Ant. vedlegg No. of append. 0
Kopi nr. Copy no.	Akkreditert test (ISO 17025) Accredited test (ISO 17025) Nei No	Kundens ref. Client's ref. Mads Bugge Amundsen	Bestillingsnr. Order no. 3380
Fordeling Distribution Original (pdf): BEWI Norplasta AS Copy 1: Kiwa/3000

Testing was done on site at Bewi Norplasta AS in Trondheim 27.05.21. Kiwa AS was on site on behalf of the client to observe the testing. BEWI Smart protector type Pin and Box in size 5 ½" was tested. See picture 1. The testing that was done was:

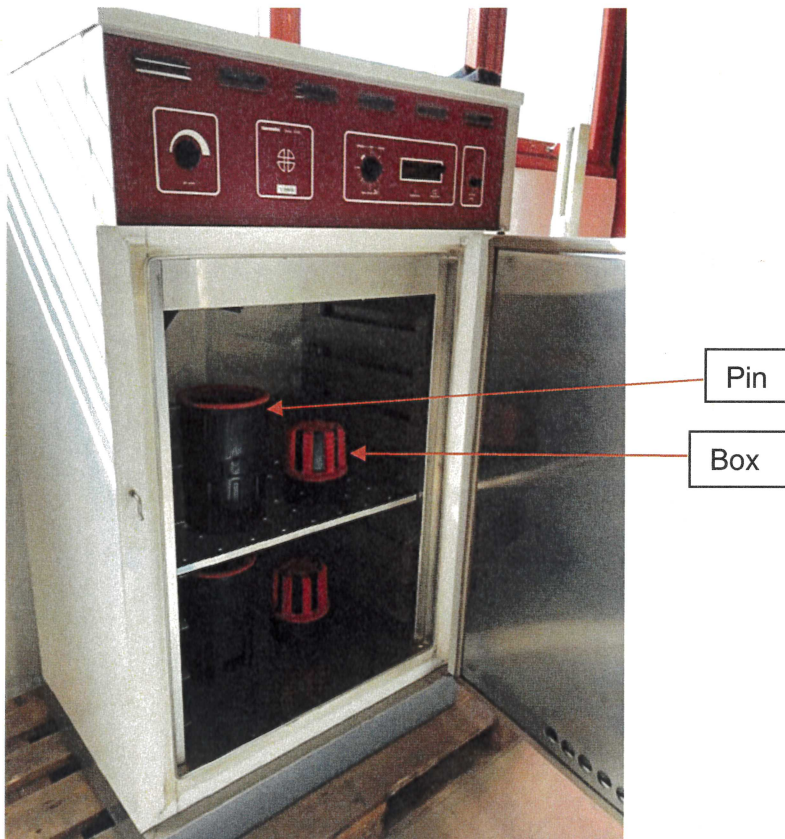
Picture 1. PIN and BOX in hot cabinet before testing.

To ensure that the protectors have been completely acquired the temperature the piece was exposed at the required temperature for at least 30 minutes before testing according to table 1 and chapter 4.

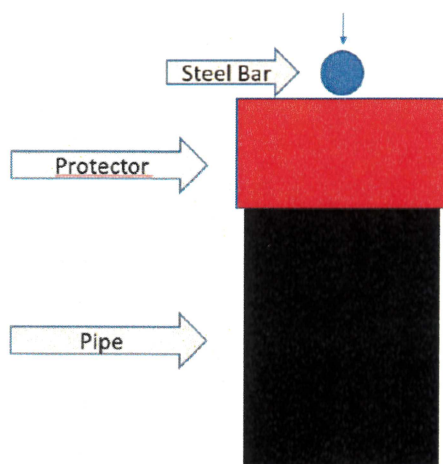
Picture 2. Axial testing.

- Steel metal bar: Diameter 38 mm
- Guillotine that reproduce requested energy
- $H \text{ (cm)} = \left(\frac{E}{m \cdot g}\right) \cdot 100$

For the tests it has been used a guillotine that reproduces the requested energy. The sample was placed in a vertical position, with the thread and the protector in the upper part. The impact was done in the middle of the protector. See picture 2 and 3.

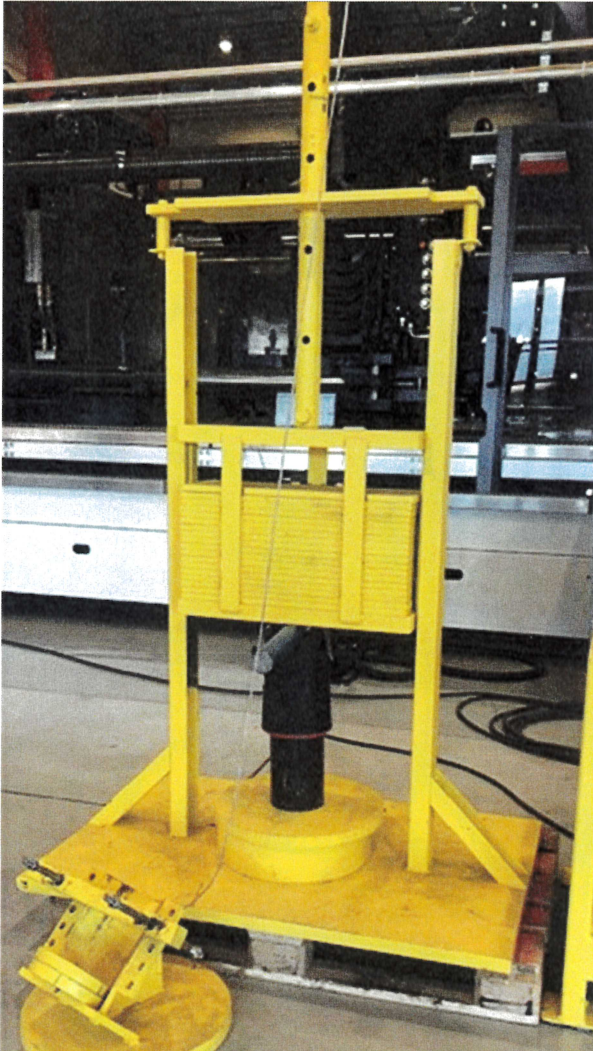
Picture 3. Axial testing with PIN protector.

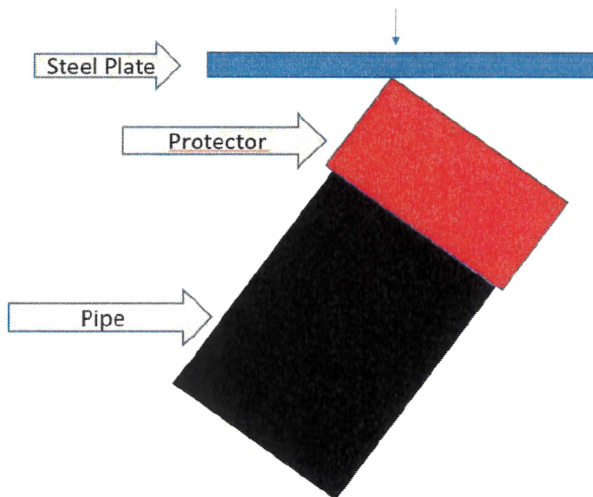
Picture 4. Angular testing.

- Flat steel plate
- Guillotine that reproduce requested energy
- $H (cm) = \left(\frac{E}{m \cdot g}\right) \cdot 100$

For angular impact it has been employed a flat steel plate. The sample was placed in a 45° angle position, with the protector in the upper part. The impact was done in the face of the protector. The impact was performed with a flat steel plate. See picture 4 and 5.

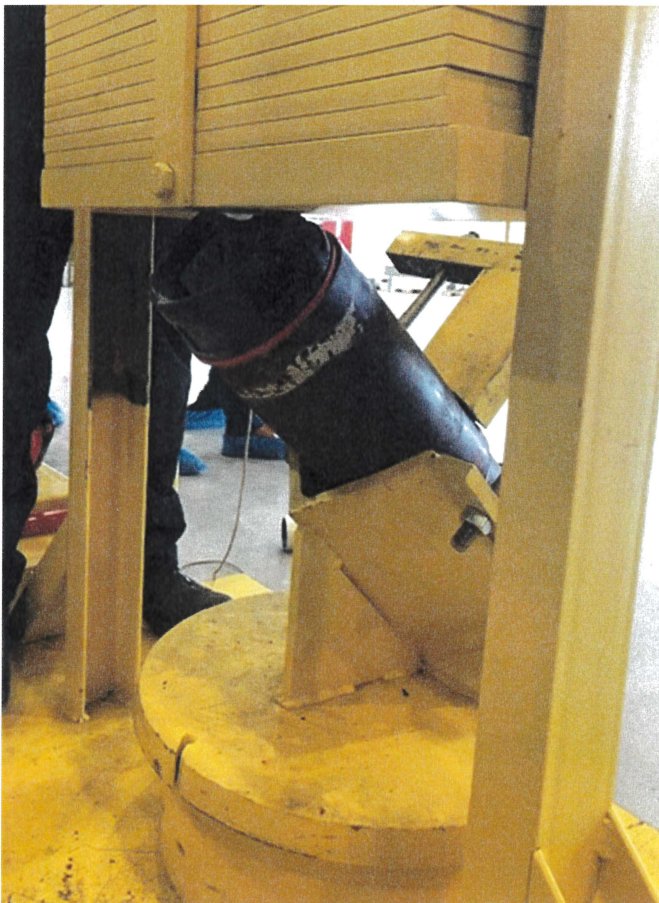
Picture 5. Angular testing with BOX protector.

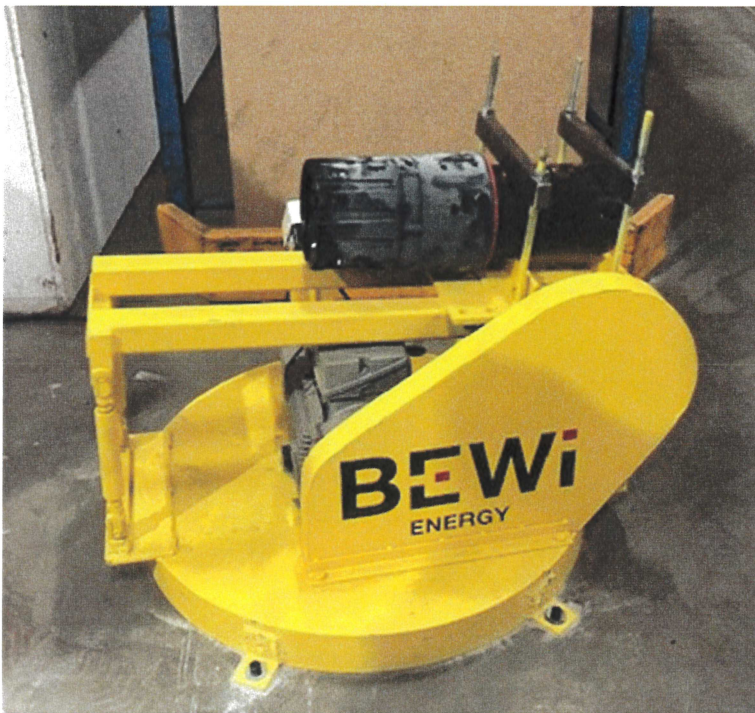
Picture 6. Vibration test.

- Vibration equipment:
 - 1460 r/min
 - Vertical displacement of 8,4 mm
 - Minimum acceleration of four times gravitational acceleration

The vibration testing was done accordance with MIL-STD-810. The protector must not fall of or out during a one-million-cycle test.

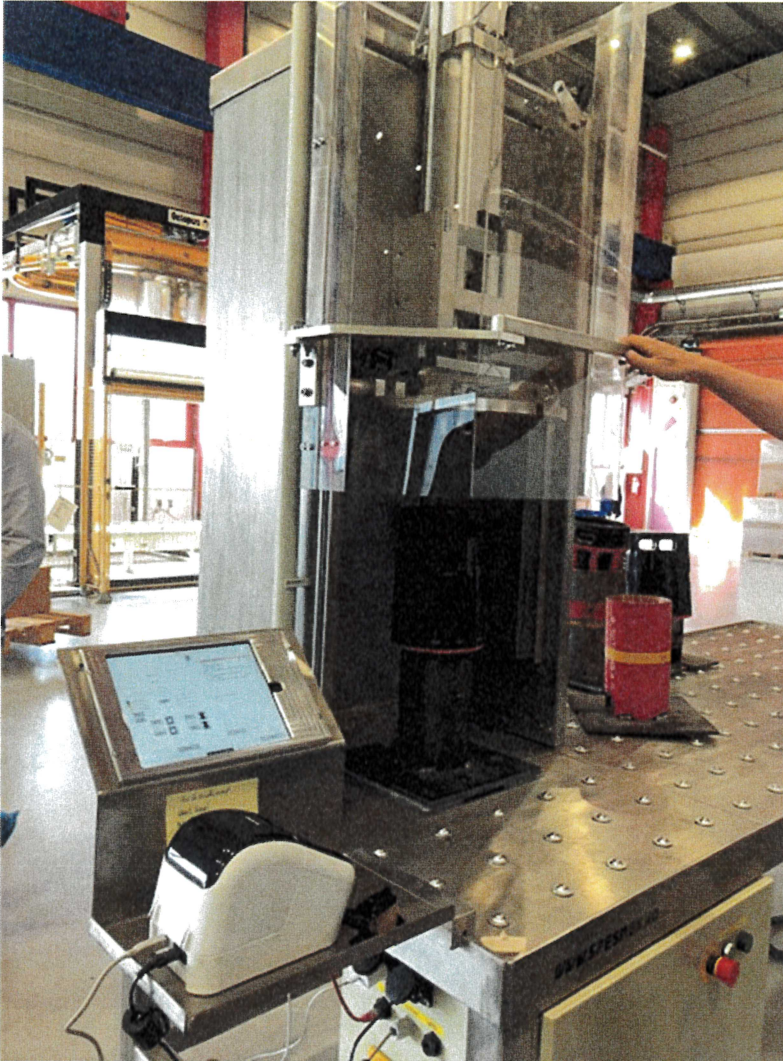
Picture 7. Stripping test equipment.

- Test equipment and jig in accordance with IADC/SPE 11396. See picture 7.
- Applies the protector as required and it was rotated 90°
- Test speed when removing the protector: 2,4 mm/sec

Stripping test was done accordance with IADC/SPE 11396 on the protector with an axial load equal to or greater than $F_{ax} = 0,18 \times v_m$ where F_{ax} is the force, expressed in kilonewtons; v_m is the linear mass of the pipe, expressed in kilograms per meter; or $F_{ax} = 60 \times W$ where F_{ax} is the force, expressed in pounds force; w is the linear mass of the pipe, expressed in pounds per foot. Protector was removed from the jugg. Force was recorded.

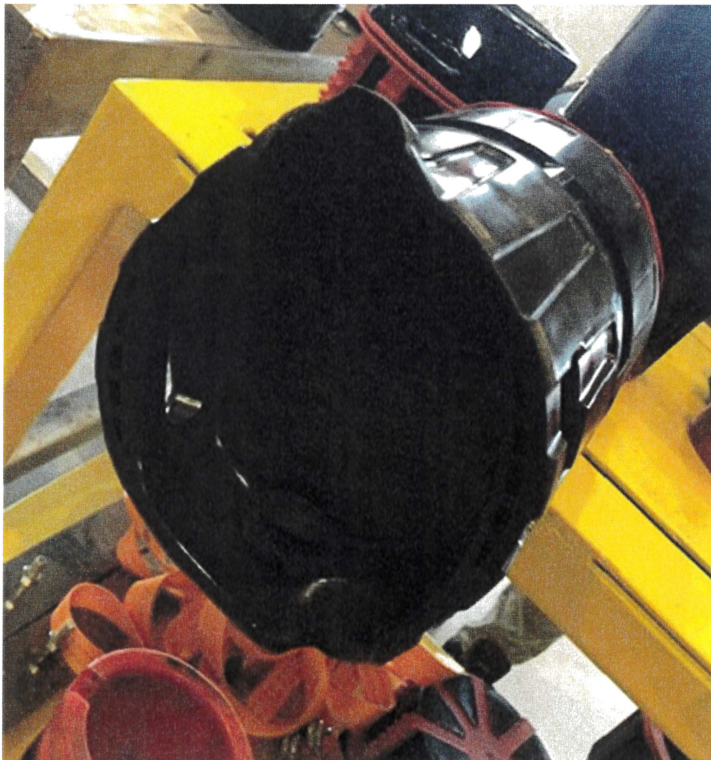
Picture 8. PIN protector after axial impact. 21 °C.

Product	Test temperature, °C	Angle of impact, °	Energy applied, J	Results
5 ½" PIN protector	66 ± 6	90	1627	No damages of connection seal and coupling thread area
5 ½" PIN protector	21 ± 6	90	1627	No damages of connection seal and coupling thread area
5 ½" PIN protector	-46 ± 6	90	814	No damages of connection seal and coupling thread area
5 ½" BOX protector	66 ± 6	90	1627	No damages of connection seal and coupling thread area
5 ½" BOX protector	21 ± 6	90	1627	No damages of connection seal and coupling thread area
5 ½" BOX protector	-46 ± 6	90	814	No damages of connection seal and coupling thread area

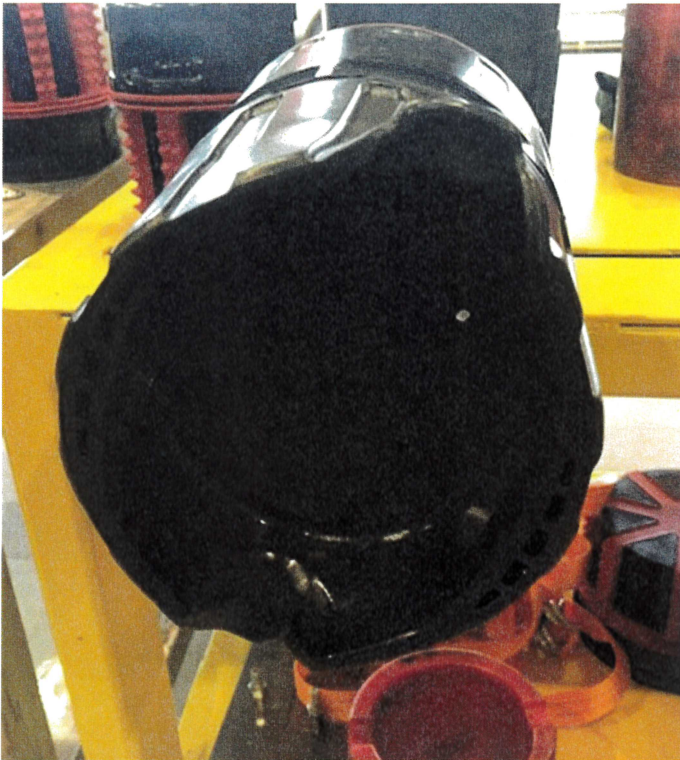
Picture 9. PIN protector after axial impact. 66 °C.

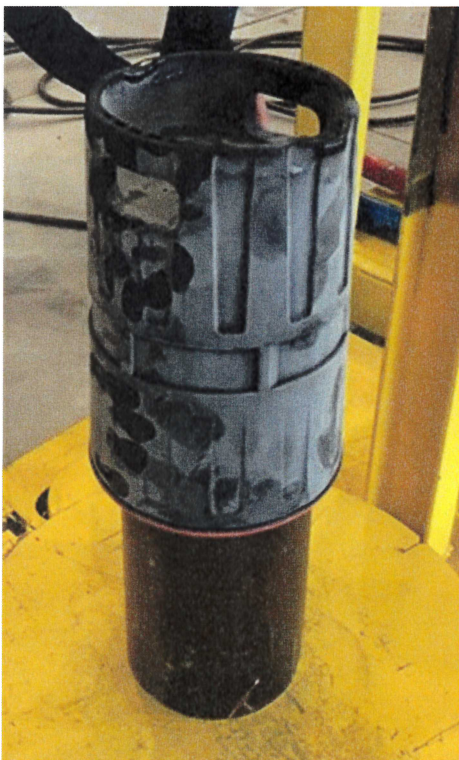
Picture 10. PIN protector after axial impact. -46 °C.

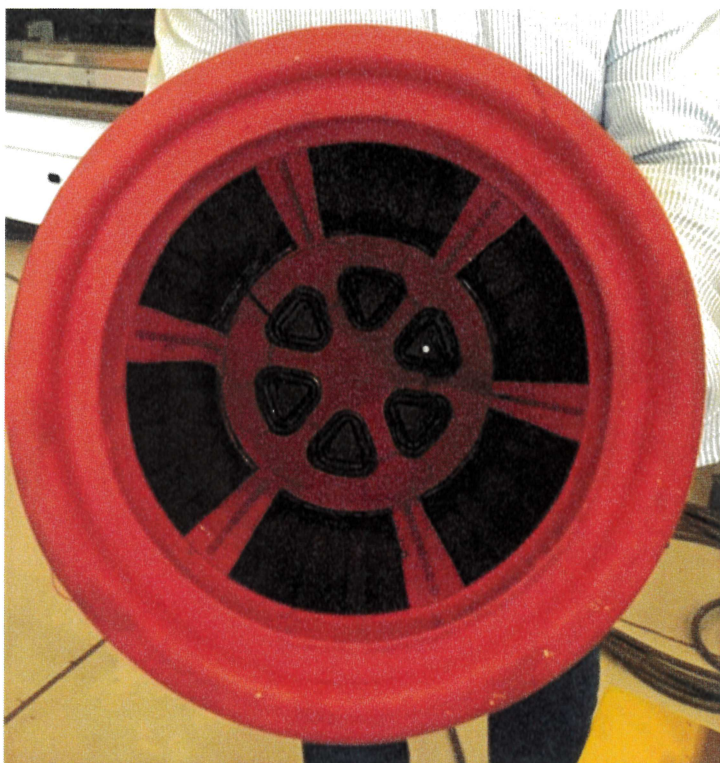
Picture 11. PIN protector after testing.

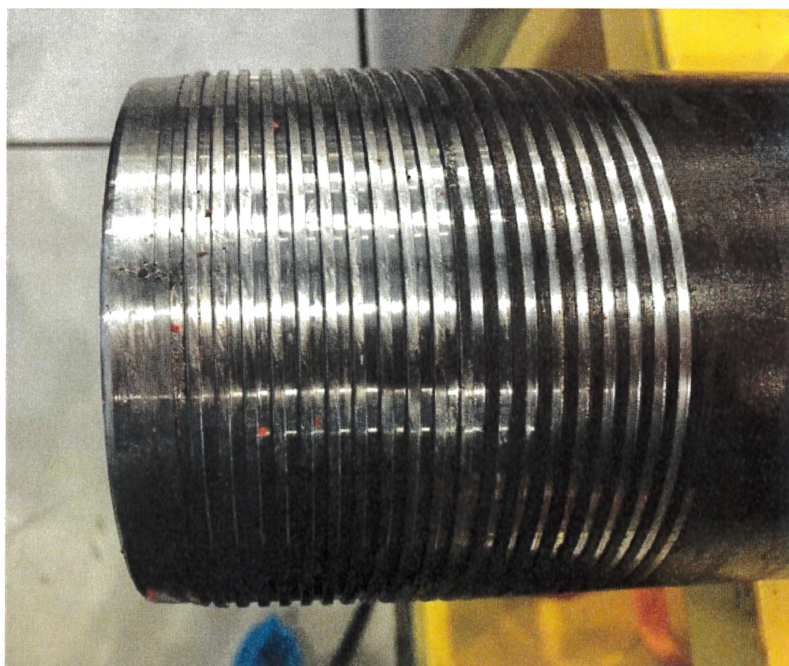
Picture 12. After testing. No damages.

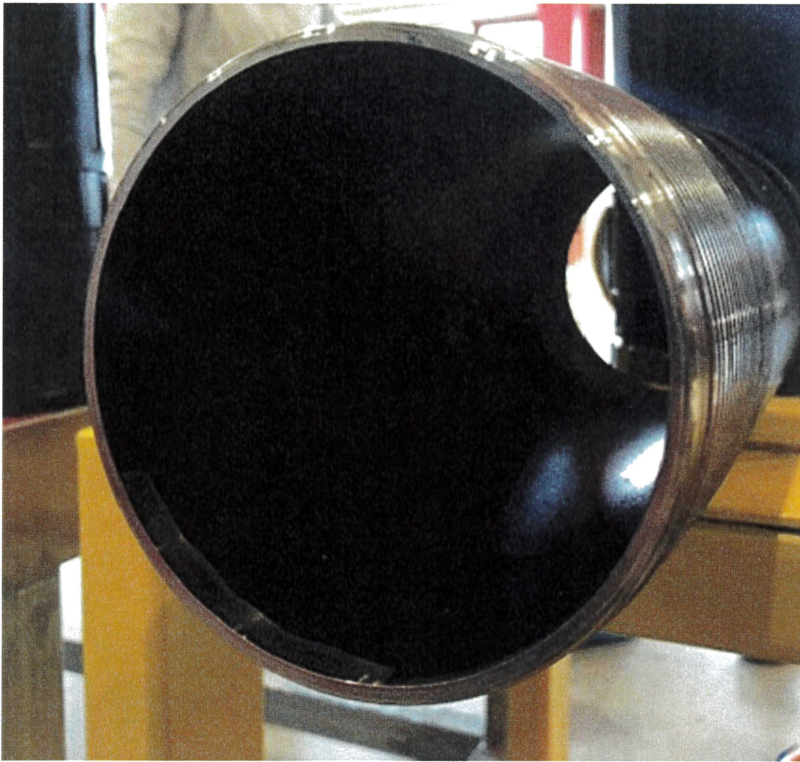
Picture 13. After testing. No damages.

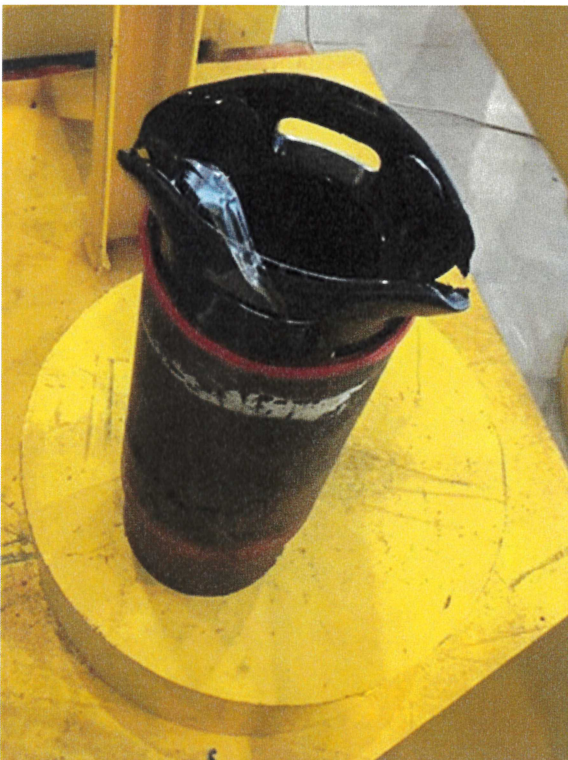
Picture 14. BOX protector after axial impact. 66 °C.

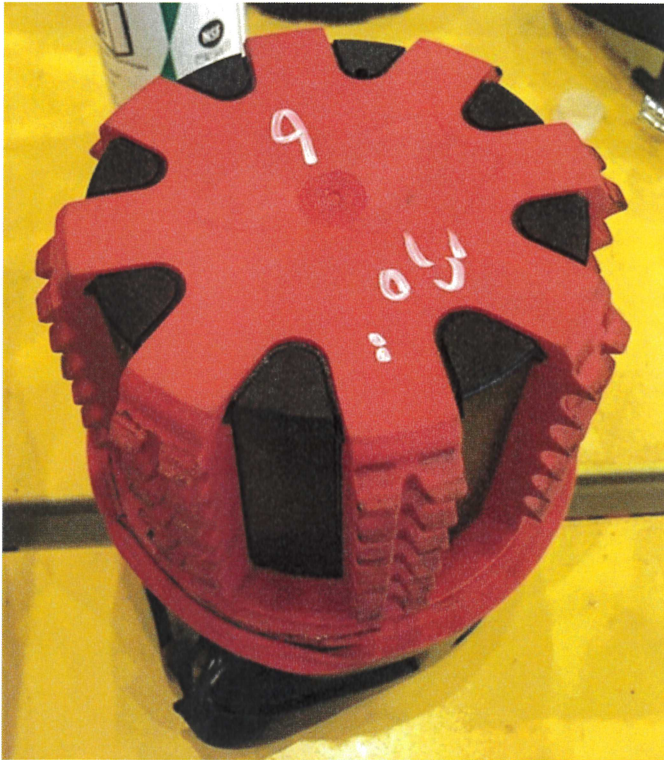
Picture 15. BOX protector after axial testing.

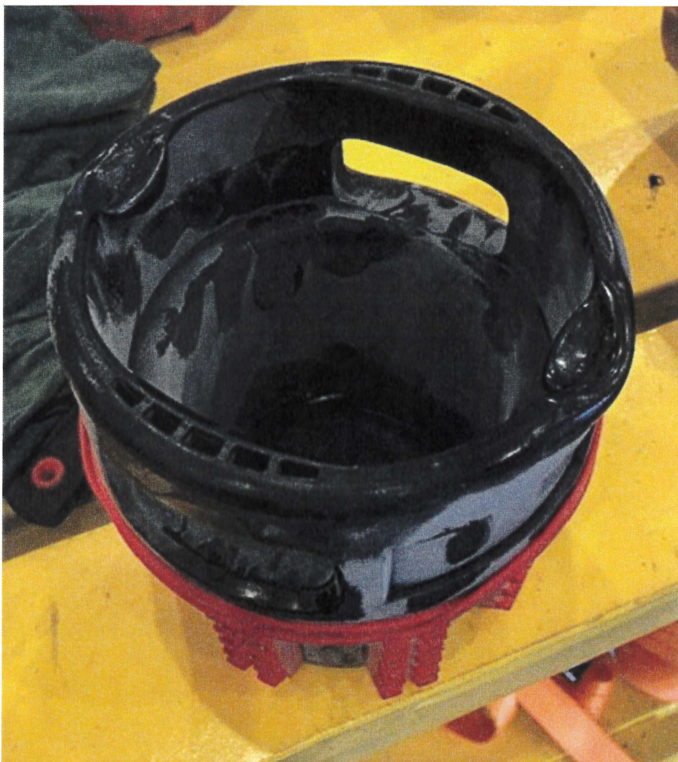
Picture 16. BOX protector after axial impact. -46 °C.

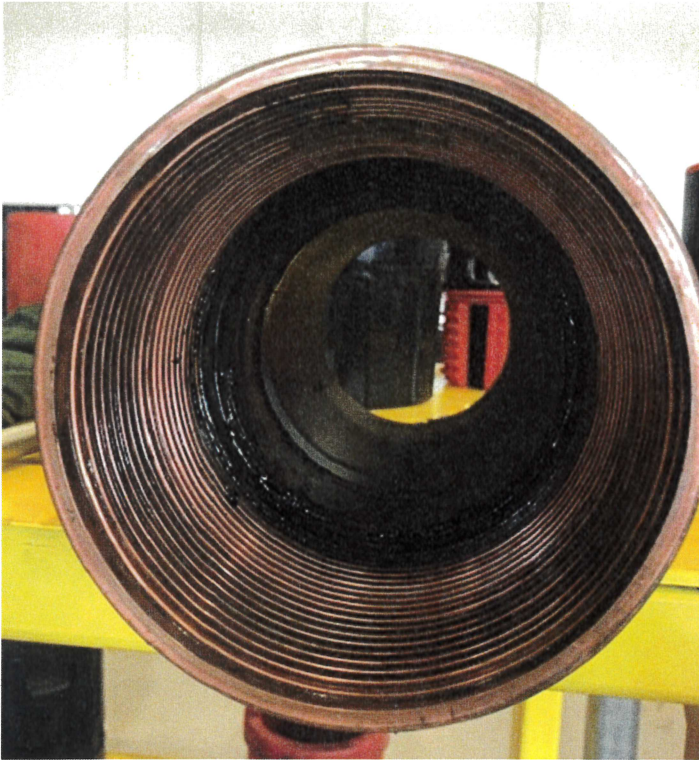
Picture 17. After testing. No damages.

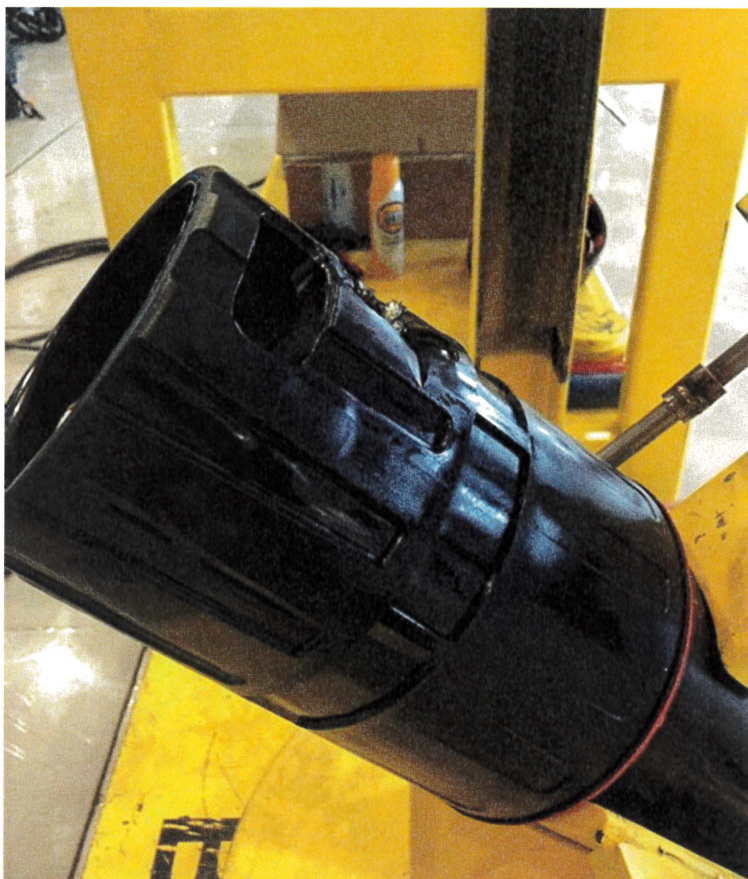
Picture 18. PIN protector after angular impact. 21 °C

Product	Test temperature, °C	Angle of impact, °	Energy applied, J	Results
5 ½" PIN protector	66 ± 6	45	814	No damages or ovality of connection seal and coupling thread area
5 ½" PIN protector	21 ± 6	45	814	No damages or ovality of connection seal and coupling thread area
5 ½" PIN protector	-46 ± 6	45	407	No damages or ovality of connection seal and coupling thread area
5 ½" BOX protector	66 ± 6	45	814	No damages or ovality of connection seal and coupling thread area
5 ½" BOX protector	21 ± 6	45	814	No damages or ovality of connection seal and coupling thread area
5 ½" BOX protector	-46 ± 6	45	407	No damages or ovality of connection seal and coupling thread area

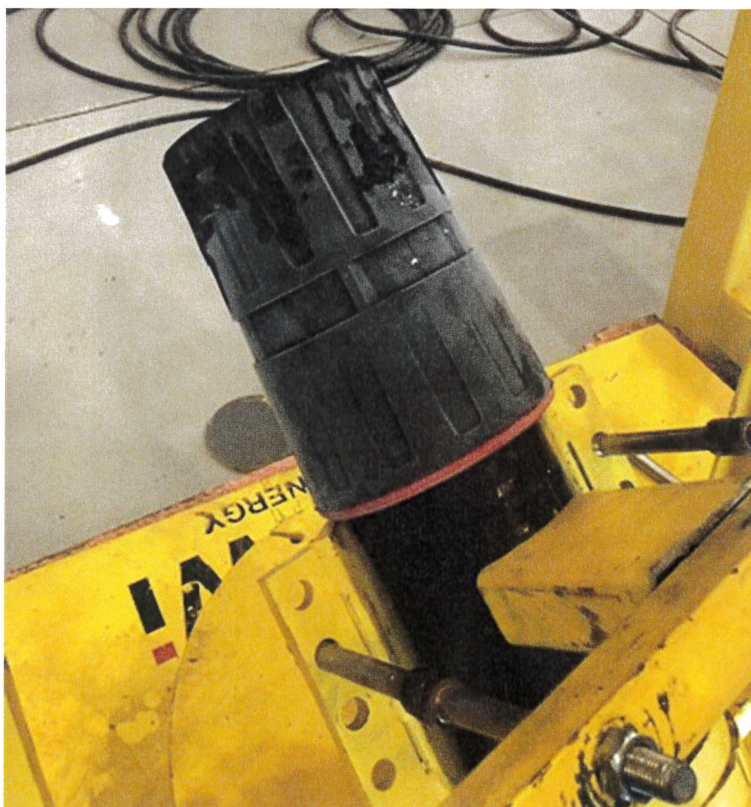
Picture 19. PIN protector after angular impact. -46 °C.

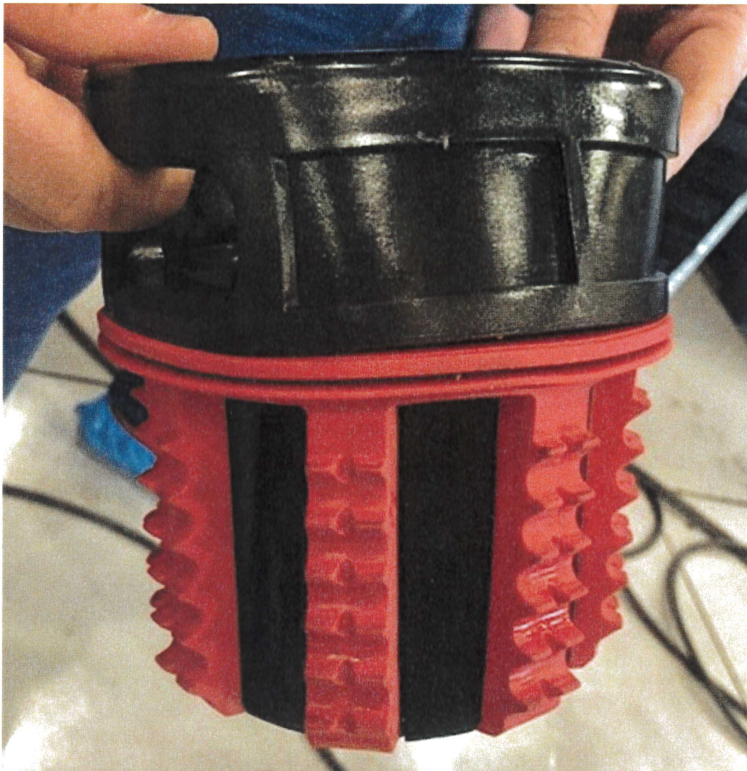
Picture 20. BOX protector after angular impact. 21 °C.

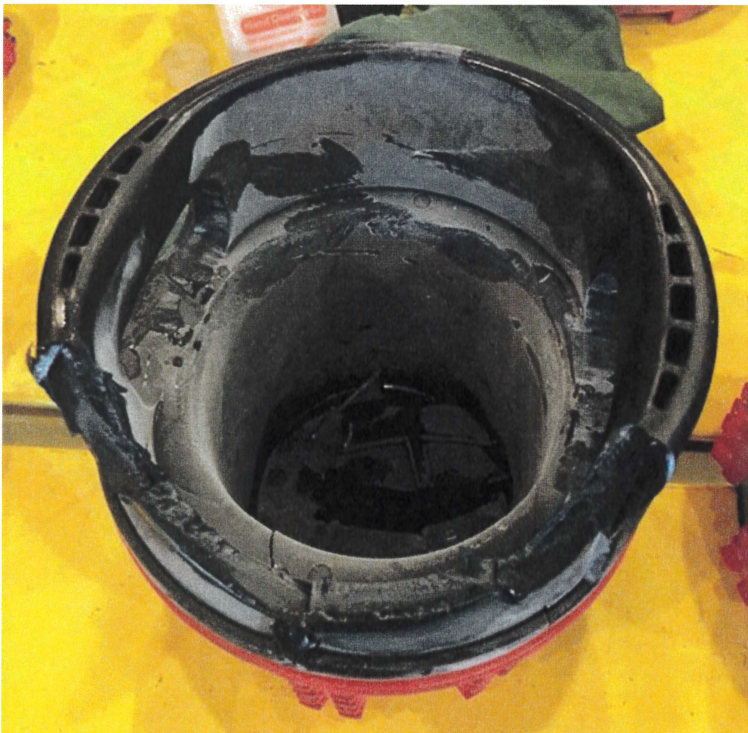
Picture 21. BOX protector after angular impact. -46 °C.

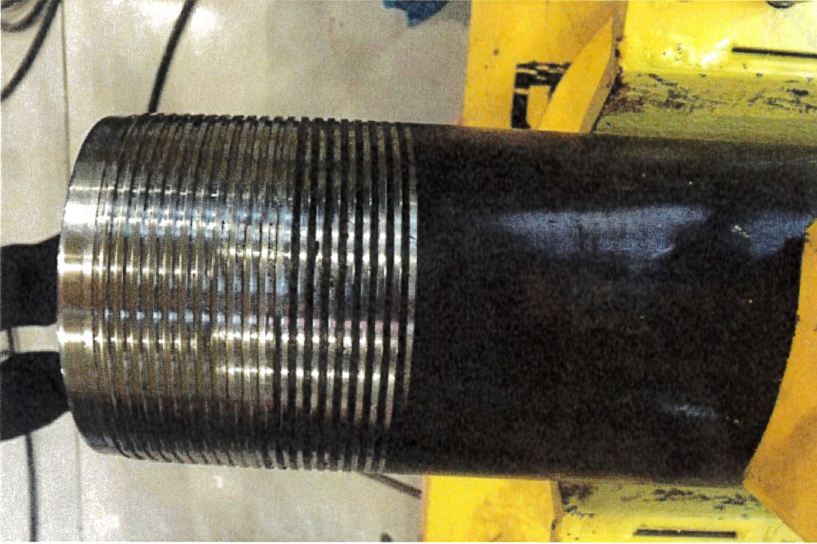
Picture 22. After testing. No damages or ovality.

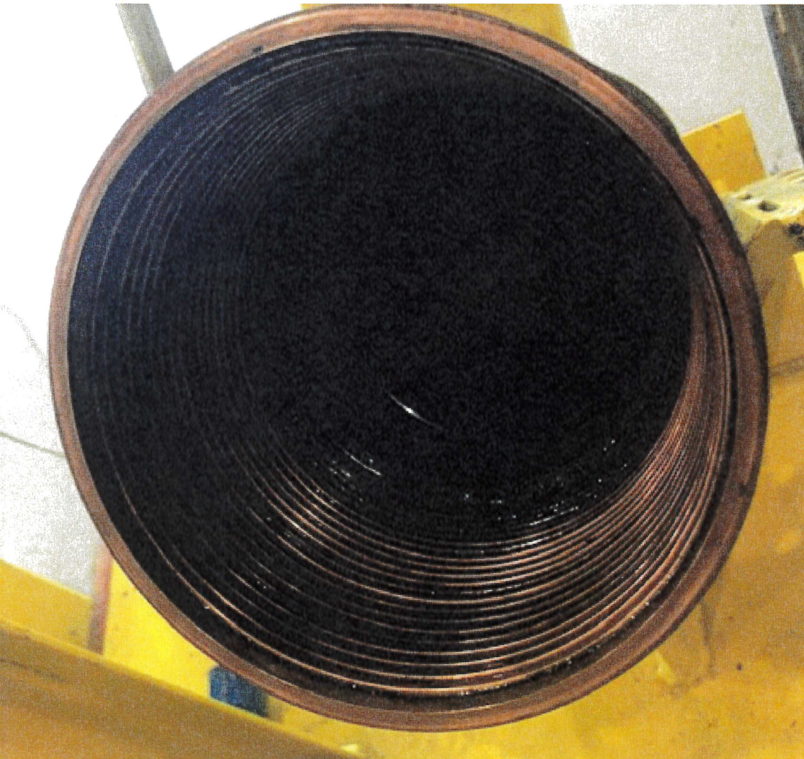
Picture 23. After testing. No damages or ovality.

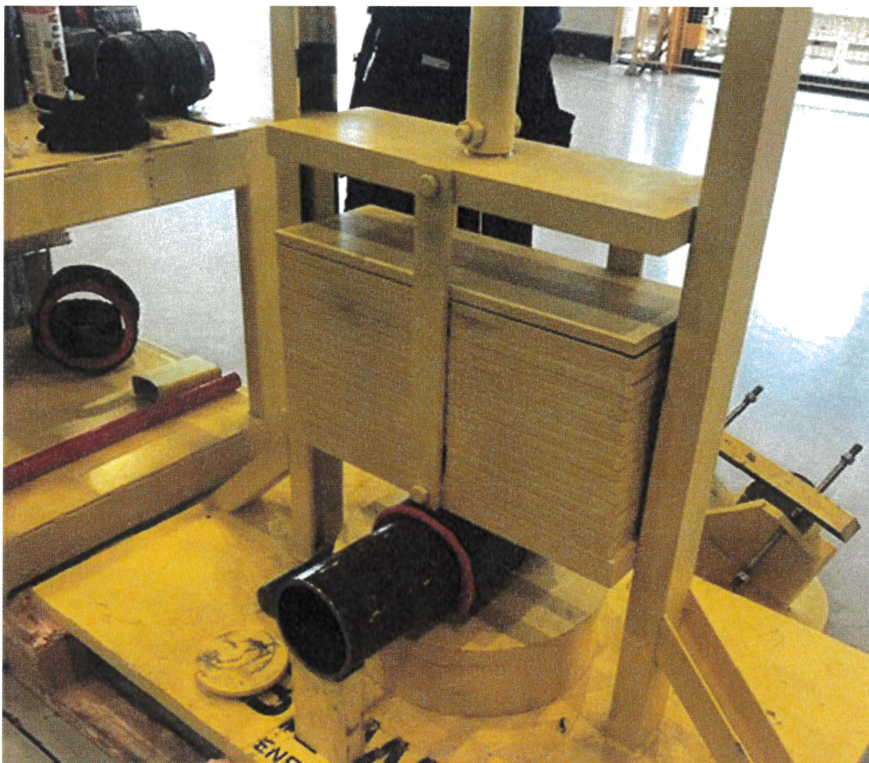
Picture 24. Lateral impact test of PIN protector.

Product	Test temperature, °C	Angle of impact, °	Energy applied, J	Results
5 1/2" PIN protector	21 ± 6	90	814	No damages or ovality of connection seal and coupling thread area

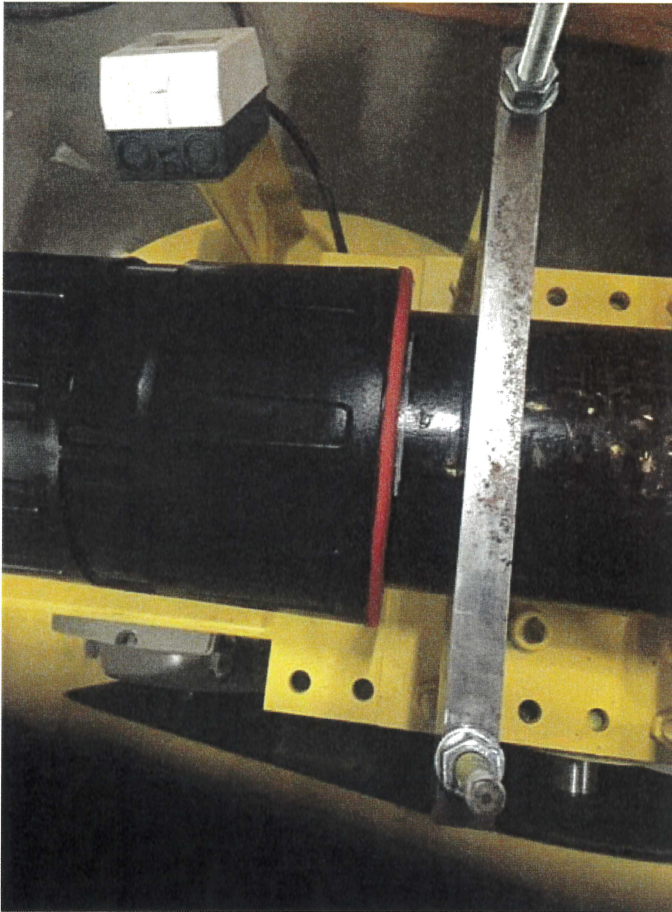
The protector did not fall off or move during a one-million-cycle test. See picture 25.

Picture 25. PIN protector after vibration testing.
